Notice of Joint Safety Committee Meeting September 17, 2024

MEETING MINUTES
IBEW 47-1245 / WLCC-NECA JOINT SAFETY COMMITTEE
June 25, 2024
Cal-Nevada JATC – Woodland Training Center

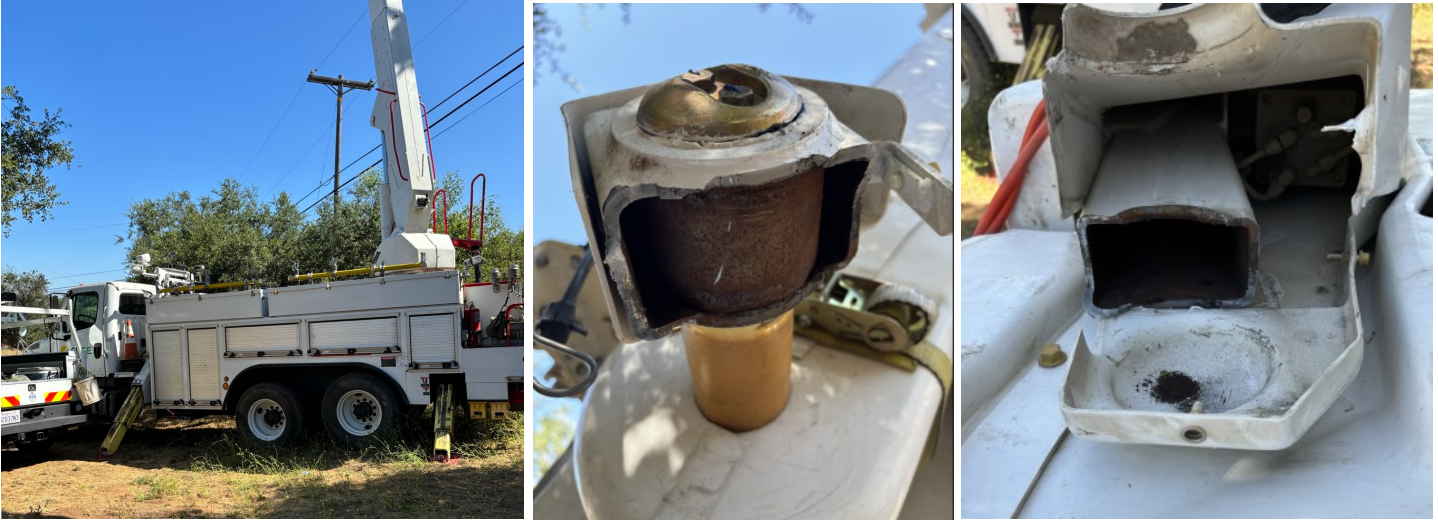
SDG&E Incident Alert

ACTIVITY: A crew was tasked with overhead line work.

INCIDENT SUMMARY: A Lineman and apprentice were working aloft in a two-person aerial lift when the bucket separated from the end of the boom at the mounting arm/pin. The bucket dropped and was hanging from the hydraulic hoses leaving the two line workers suspended in their personal fall arrest systems. The two workers were rescued by another lineman in a service bucket and lowered to the ground one at a time.

Upon inspection, a second A72 was found to have crack(s) in the weld at a similar location.

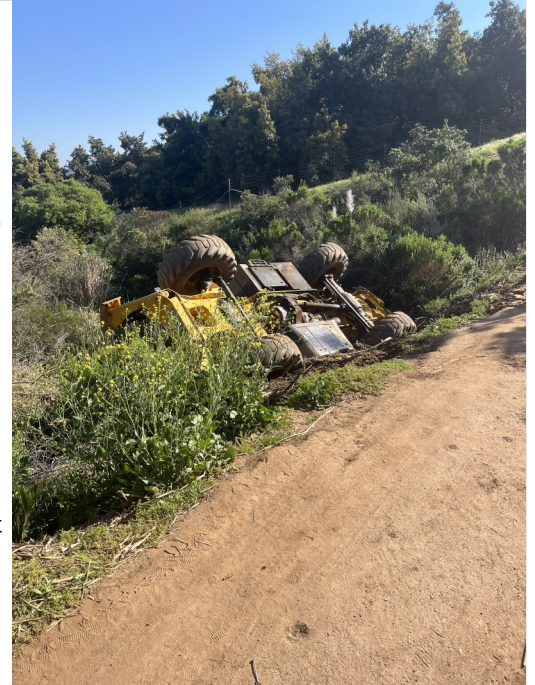
This debrief is from an incident that occurred in April of 2024 where a contracted crew was working in an area where there had been rain the week prior, which did cause some erosion to the access roads on the project. At one point, the crew did need to install plates along one of the steep access roads to improve safety for vehicles and heavy equipment needing travel on that access road. There was also another access road that was flatter but narrower and had a pond on the left side and an "8'10" sharp decline on the right side as you exited the jobsite.

When the crew was concluding work, the operator of Reach Lift Forklift (RLF) was driving to the designated parking area. The operator and Foreman decided the narrow access road was the safest route to take as the other access road was steeper and there did not appear to be any issues with this particular narrow access road. The operator began his descent towards the narrow access road with the assistance of two spotters, one in front and one in back of the RLF. The operator realized that he was coming in at somewhat of an angle, so he slowed down to straighten out the RLF and then proceeded. As he was crossing the narrow access road, the operator began to feel the terrain beneath the front right area of the RLF give way, so he attempted to put out the right outrigger to try to level out. At that time, the right side of the road gave way and the RLF rolled over to the right with the operator seat belted in the cab with ROPS (roll over protection system). The spotter and two other witnesses rushed over to help the operator out of the cab and the operator was taken to the hospital. As a result of this incident, the operator sustained two fractured ribs and a fractured elbow.

1. The operator chose to utilize a narrow access road and the terrain gave way underneath the weight of the heavy equipment, causing the RLF to roll over.
2. The operator and foreman determined that the other access road that had been plated for easier travel was not the safest route for travel because it had a steep incline.
3. Operator cab of RLF was on pond side of road, not the steep side of road, therefore operator could not see how close to edge of steep side the RLF was.

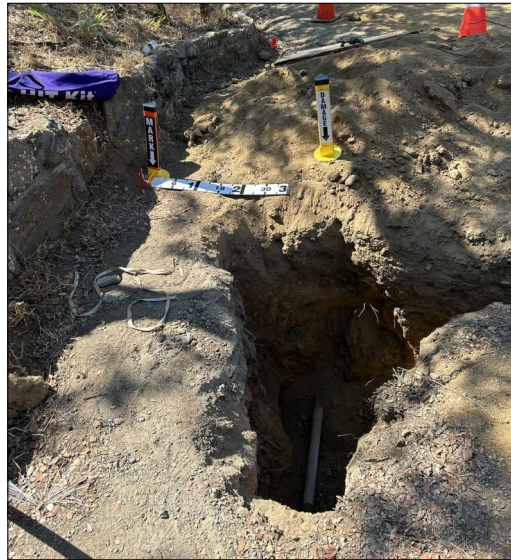
[Location of damaged wire]

ACTIVITY: Crew members were excavating to install an infrastructure.
